Gold King Mine Site Operations

Gold King Mine Adit

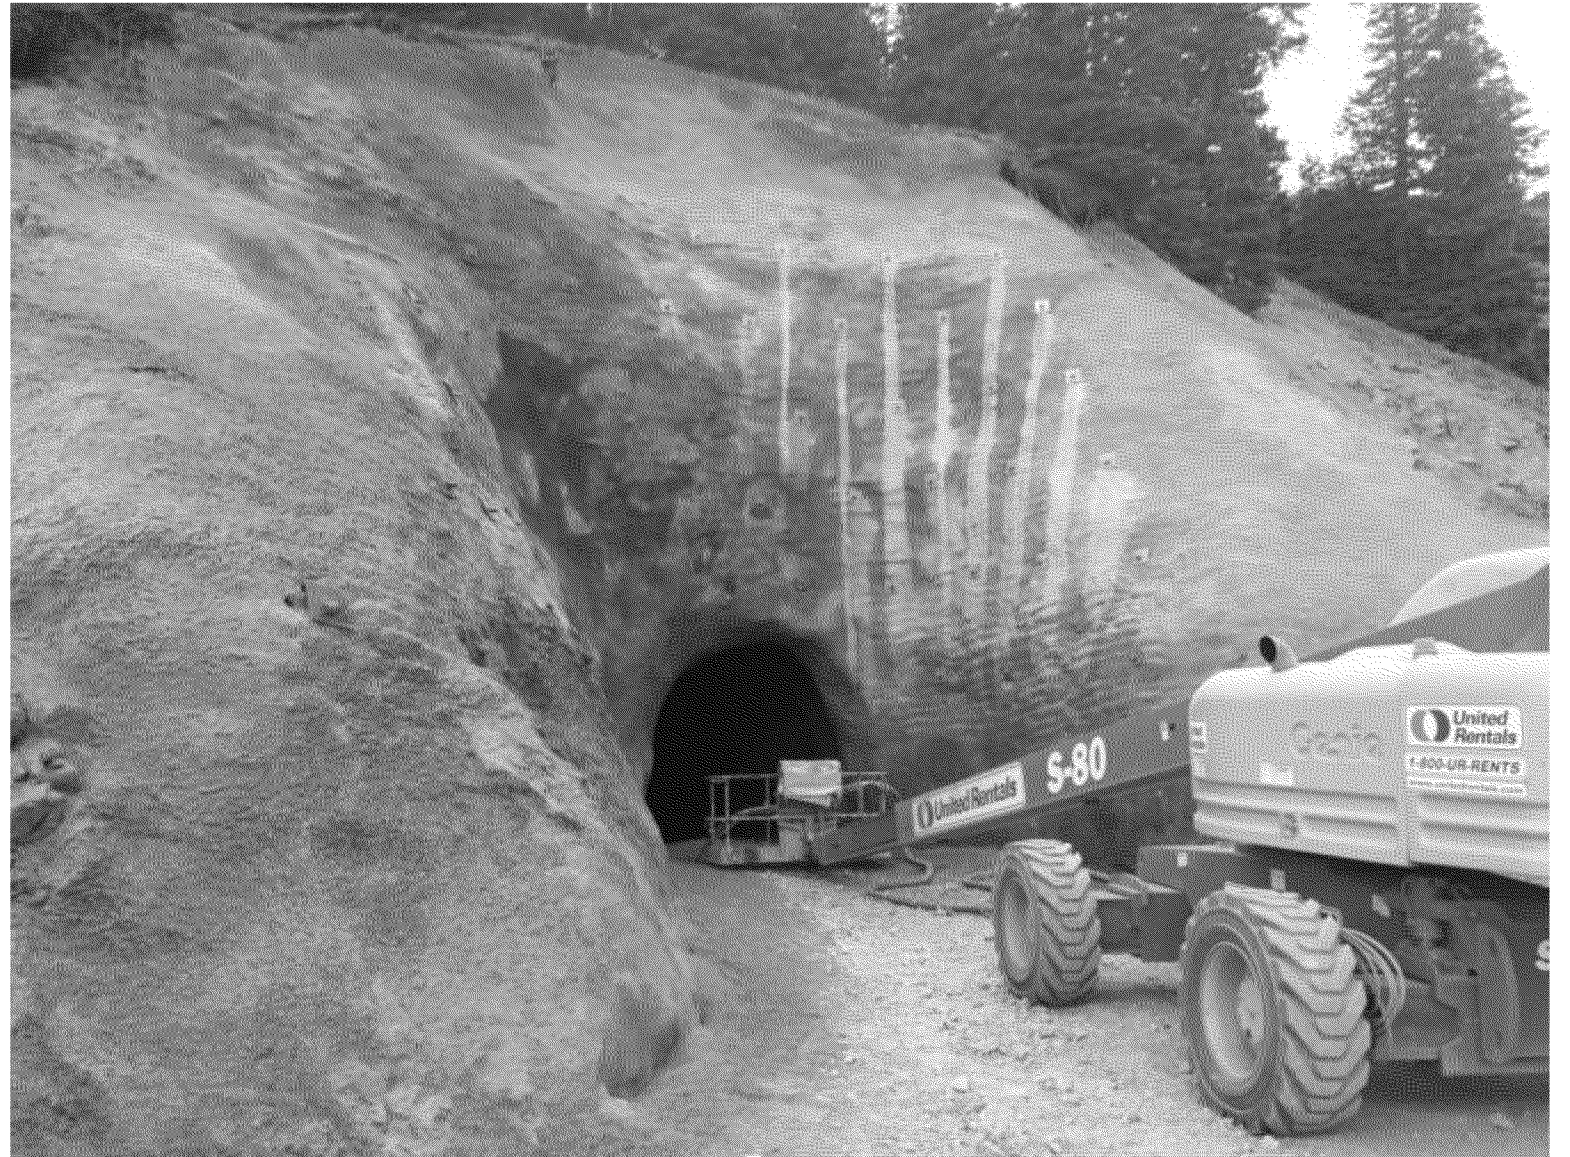
Shot Crete
stabilizing
opening

- Stabilizing mine access to establish control of water flow over the winter
- Piping water discharge approx. 4600 feet from mine to treatment ponds at Gladstone
- Further entry and stabilization will occur next season
